CITY OF HOLTVILLE

**Request for Proposals for
Engineering Design & Miscellaneous Services**

**for the
Holtville Alamo River Trail Trestle Bridge Project
(2023-24)**

**Re: City of Holtville, Train Trestle over the Alamo River – Updated Repair Estimate
SWE Job No. 600-912**

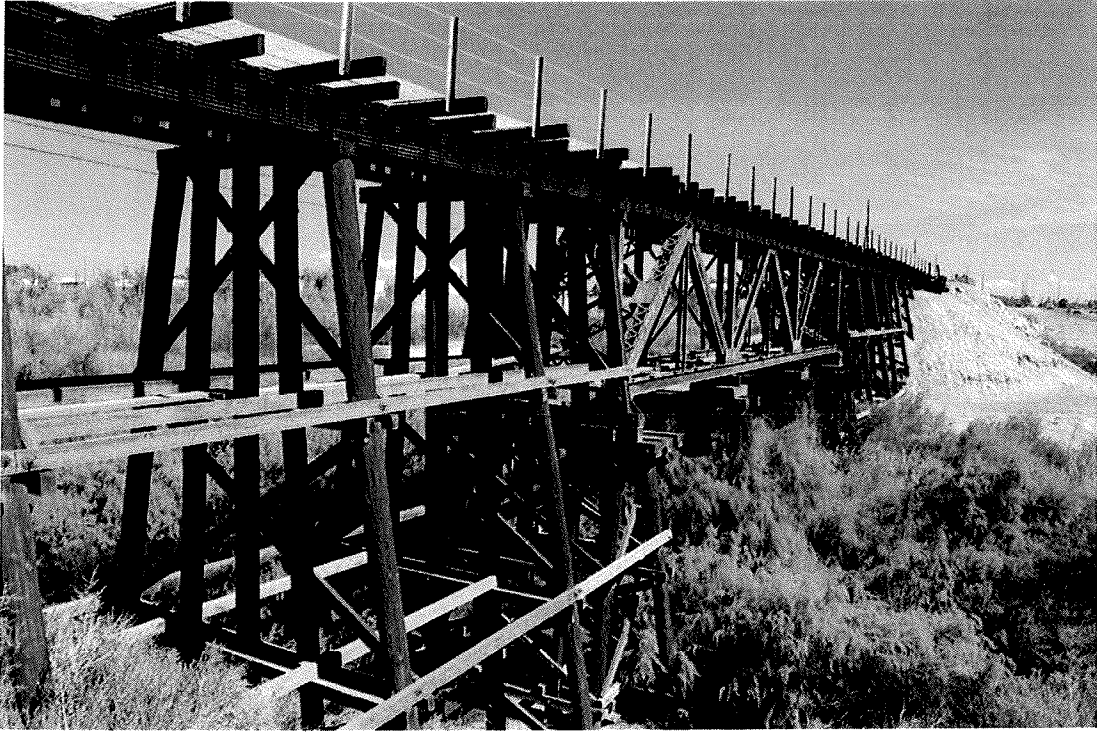
In Appendix C, a set of representative photographs are enclosed from the site visit. Photo 1 was an original photo of the trestle taken on October 13, 2006, looking north from the south abutment.

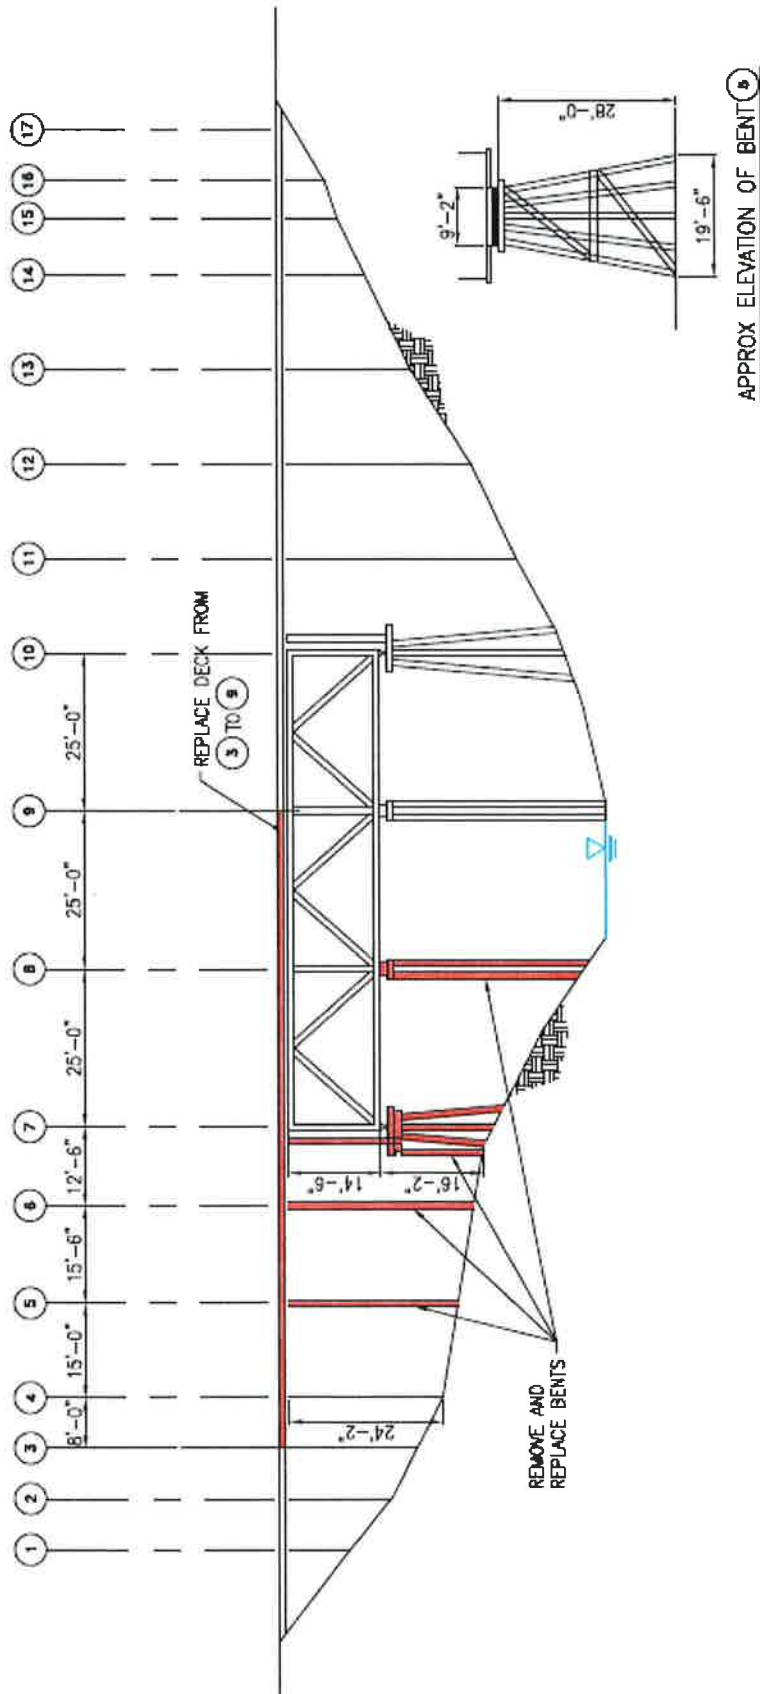
BRIDGE ELEVATION

♦ NOTE: ALL DIMENSIONS ARE ROUGH ESTIMATES.

ELEVATION LOOKING EAST
 NO SCALE

Although we did not perform any destructive testing, we were able to observe the extent of the fire damages of the trestle which actually is quite clear and distinct. Appendix B defines numbering and the locations of the bents and areas of damage. The length of trestle deck from bent 3 to 9, composed of wood beams, was charred and no longer has any structural capacity. Bents 5 to 8, although still standing, had sustained major damages. The north end of the steel truss had been engulfed in fire but the steel members do not appear to have buckled. As a result, it is likely that the steel truss retain a capacity that can support the proposed pedestrian loading. It is possible that any major earthquake or flood can cause further damage or even collapse of the bents. It is recommended to keep people away from the trestle and its surrounding area for safety.

Photo 2 shows the fire engulfed trestle. General views of the trestle showing charred timber bents are enclosed in Photos 5, 6, 7, and 8. Photos 9, 10, 11, 12, 13, and 14 showed the condition of the steel truss. Photos 15 and 16 showed the charred deck of the trestle. Photos 17 and 18 showed elevation of the truss, with gaps between the bottom of the truss and the top of the wood blocks of the bents. Photos 19 and 20 showed elevations of the trestle looking west and east with bent number indicated.

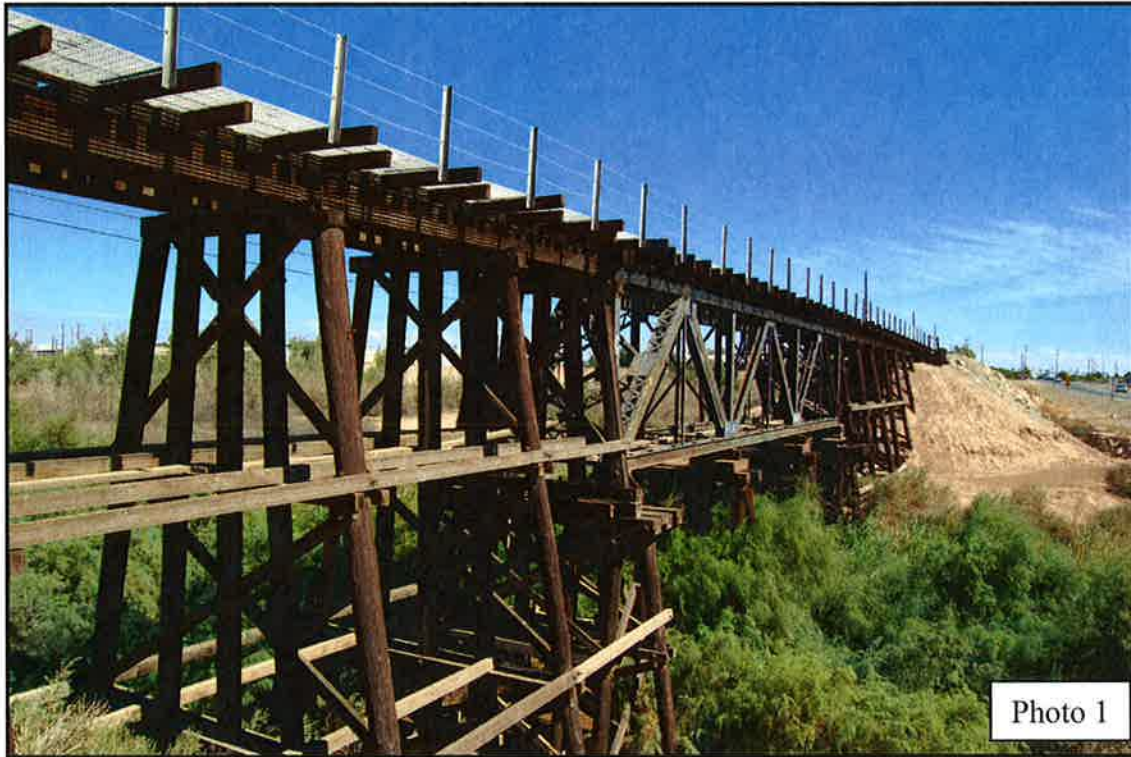
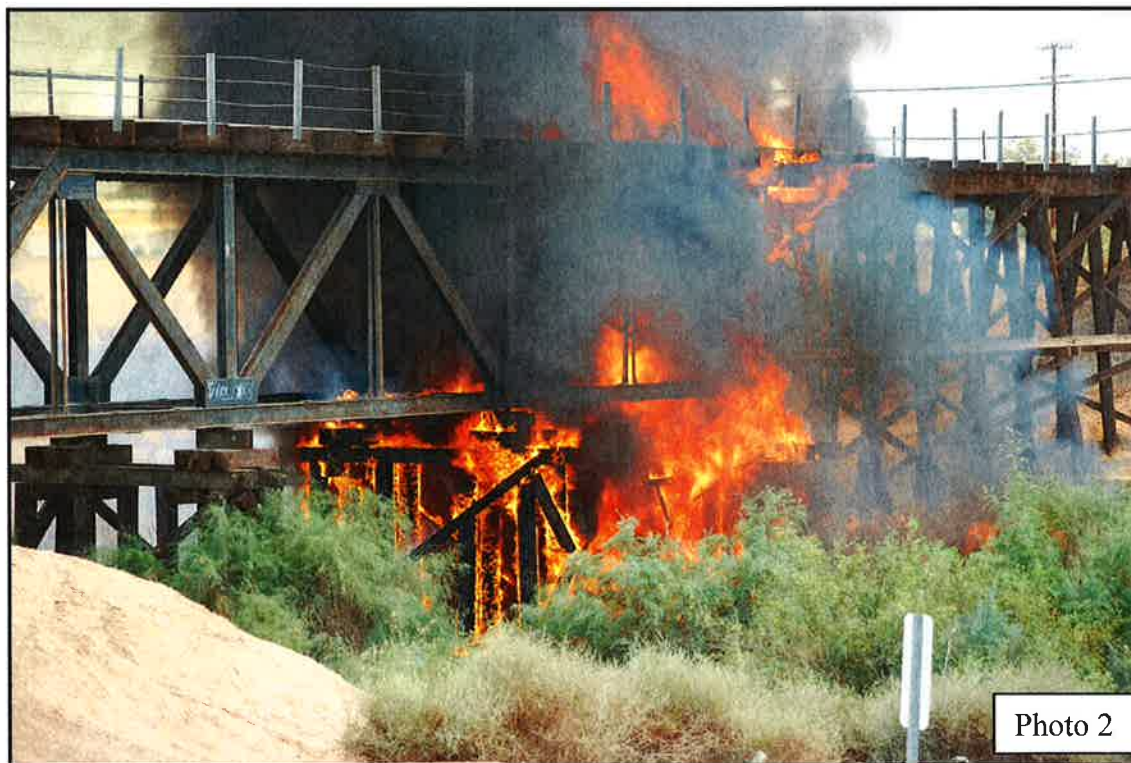
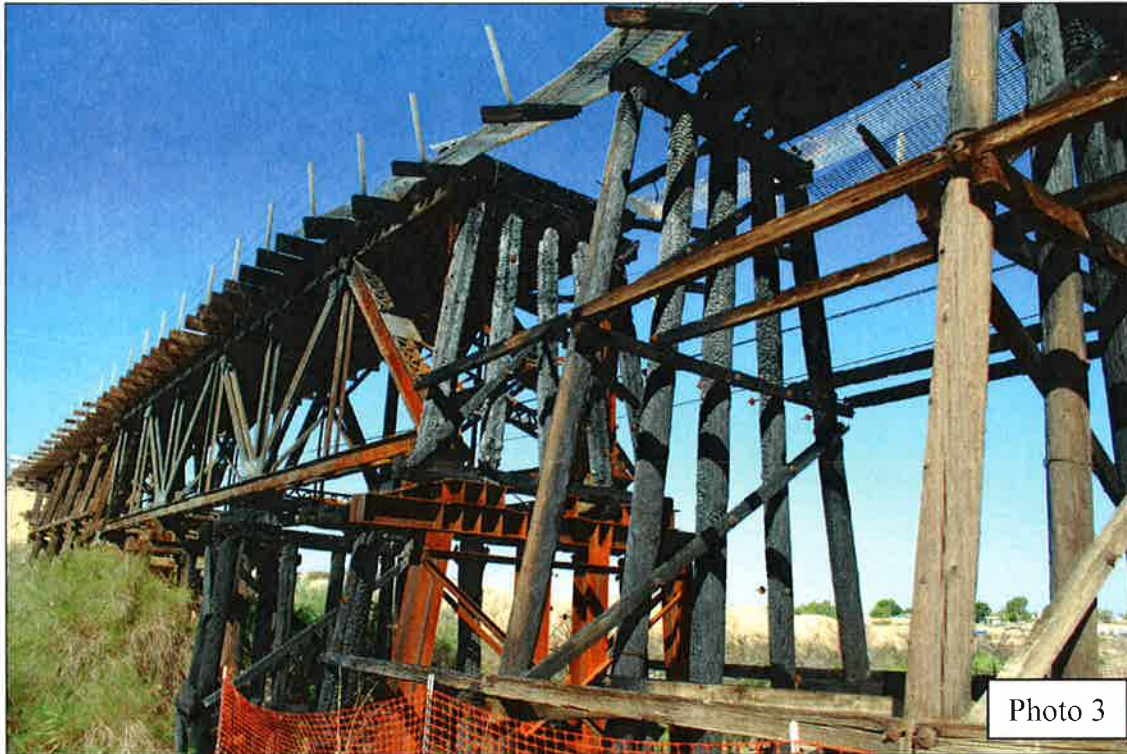
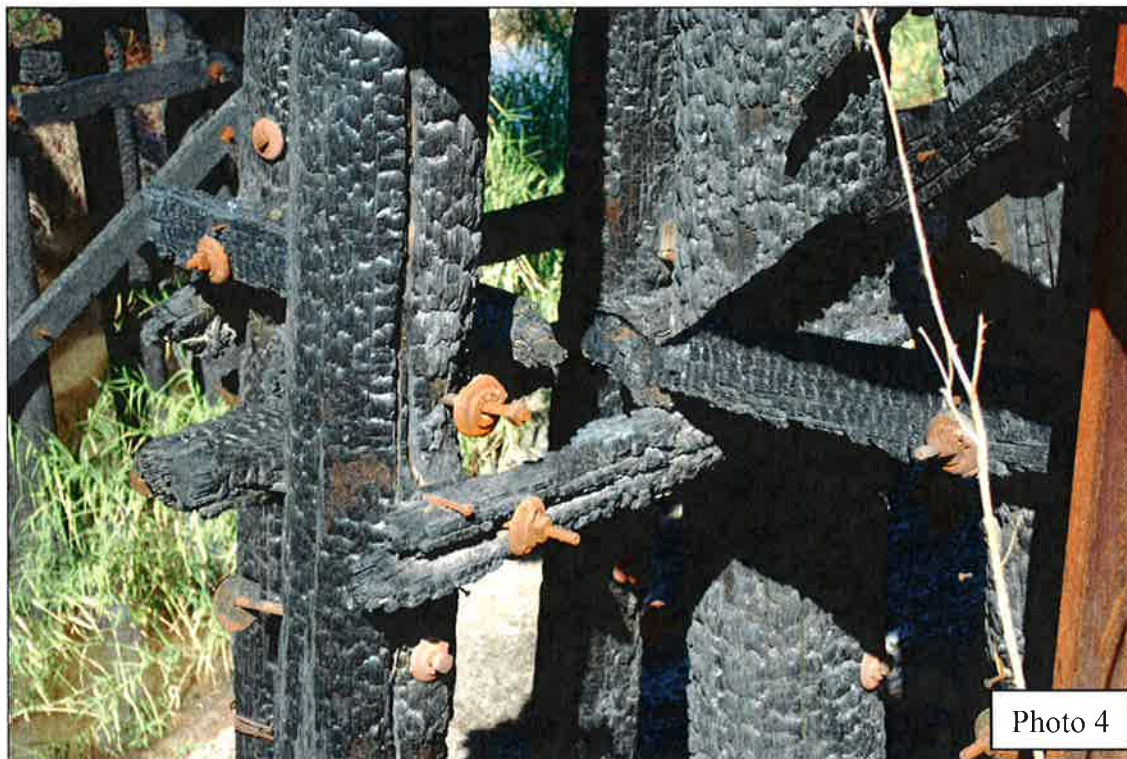
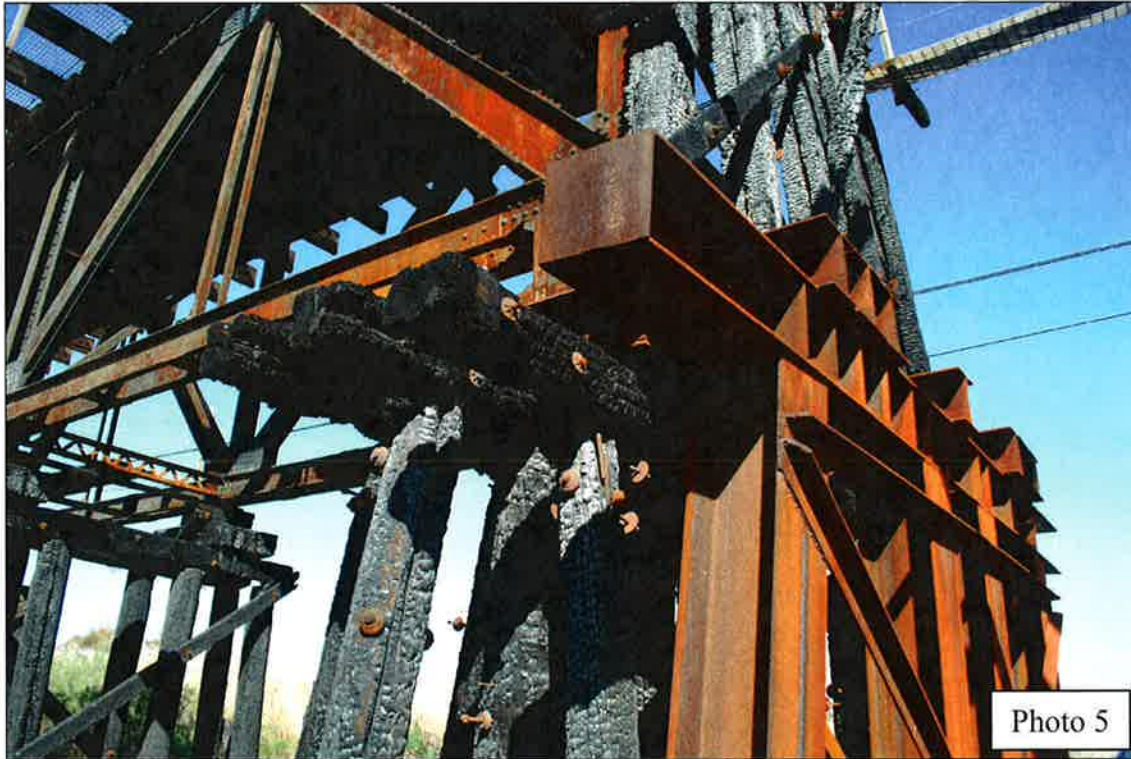
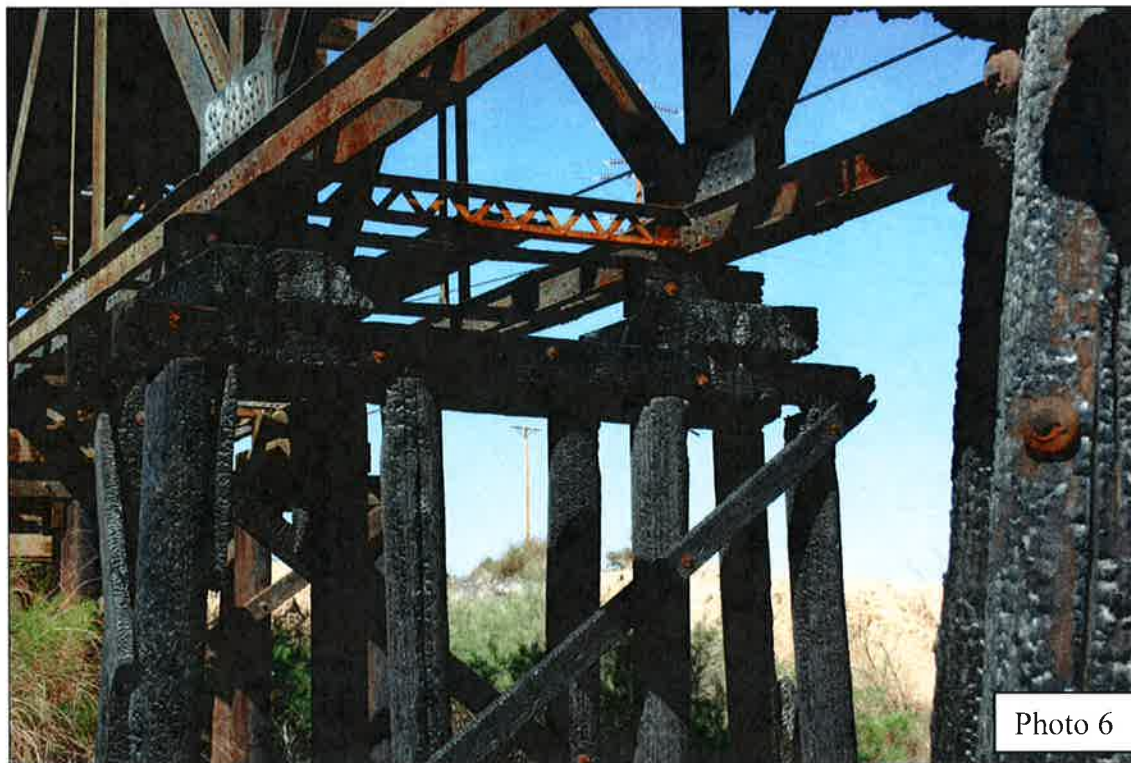
Appendix C
PHOTOGRAPHS

1. Deck and support cross beams from bent 3 to 9 completely damaged and require complete replacement.
2. Grating and railings from bent 3 to 9 require complete replacement.
3. Bents 5 to 8 sustained major damages and require complete replacement.

1. Replace/restore trestle top deck, beams, grating, and railing from bents 3 to 9 as before.
2. Replace/restore bents 5 to 8 as before. It is possible to replace the bents with timber which is preferred by the City. It is also possible for the repair contractor to investigate the replacement with the method of posting the timber piles.
3. Verify that the steel truss is capable of carrying the proposed loading with further investigation and testing of the steel truss. Also, from Photos 11 and 12, repair and rehabilitation of the north end of the steel truss support are required.
